A defective contact — a minor component of a control unit in the Airbus A319-111 electrical power generating system — was identified as the likely cause of an intermittent current-sensing fault that cascaded into an extensive malfunction and left the flight crew without several major systems and unable to communicate with air traffic control.

Partial-Panel Puzzle

The A319 pilots were powerless to rectify an electrical system gone haywire.

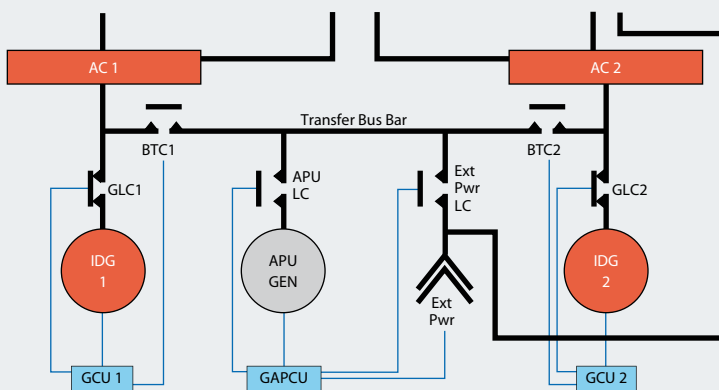
Figure 1 (p. 18) shows the system in normal operation, with both engine-driven generators — labeled “IDG1” and “IDG2” in the diagram — on line, the generator line contactors (“GLC1” and “GLC2”) closed and the transfer bus tie contactors (“BTC1” and “BTC2”) open, resulting in each generator powering its own network.

Normal Configuration of the A319 Electrical System

Note: Instead of the normal configuration, the incident aircraft was dispatched for the flight from Spain to England with the no. 1 integrated drive generator (“IDG1”) inoperative and the auxiliary power unit (“APU GEN”) engaged; the no. 1 generator line contactor (“GLC1”) was open, the APU line contactor (“APU LC”) was closed and the no. 1 transfer bus tie contactor (“BTC1”) was closed.

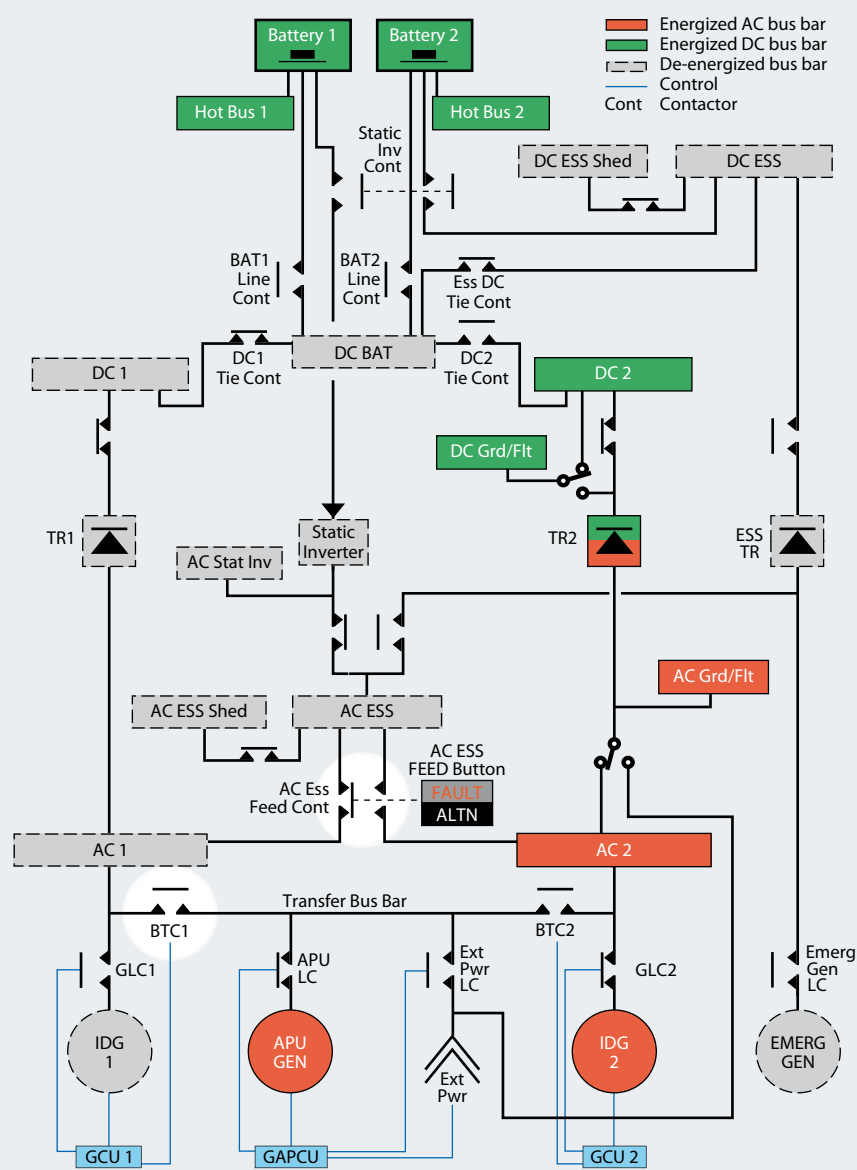
Figure 2 shows the condition of the electrical system immediately after the malfunction. Basically, the no. 1 network had been de-energized. The no. 1 transfer bus tie contactor — labeled “BTC1” in the diagram — had opened, isolating the APU generator, which was still operating but was now unable to power the network.

Post-Malfunction Configuration of the A319 Electrical System

The malfunction of the electrical system was traced to a defective contact in the no. 1 generator control unit (“GCU1” in the diagram), which performs system testing and monitoring as well as regulating the output of

The defect had caused the GCU to erroneously detect a “welded” generator line contactor, a condition that occurs if the contactor remains closed after being selected open. Consequently, the GCU locked the no. 1 transfer bus contactor open “to prevent it from closing and potentially creating a hazard by allowing other power sources to motor the IDG through the apparently closed [generator line contactor],” the report said.

Based on the findings of the investigation, the AAIB issued 14 recommendations, including a call for modification of the A320-series electrical system to automate the transfer of power to the AC essential bus when the no. 1 AC bus is lost. Airbus responded with a service bulletin recommending such a modification, and the European Aviation Safety Agency told AAIB that it will issue an airworthiness directive mandating compliance with the manufacturer’s bulletin.
