DAMAGE IN ANCIENT CHURCHES DURING THE 9TH OF JULY 1998 AZORES EARTHQUAKE

Luis GUERREIRO¹, João AZEVEDO², Jorge PROENÇA³, Rita BENTO⁴ And Mário LOPES⁵

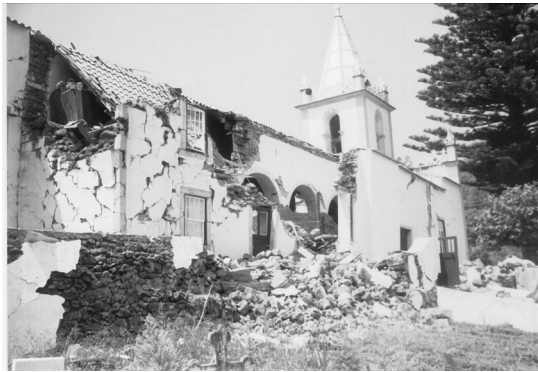
Figure 5 – Ribeirinha church.

In figure 5 to 10 some examples of the identified potential collapse mechanisms are presented. In figure 5 one can see the severely Ribeirinha (no. 4) church with a clear view of the collapse of the lateral nave due to an out plane movement of the exterior wall (18). In this figure severe damage is also visible in the exterior walls of an adjacent building.

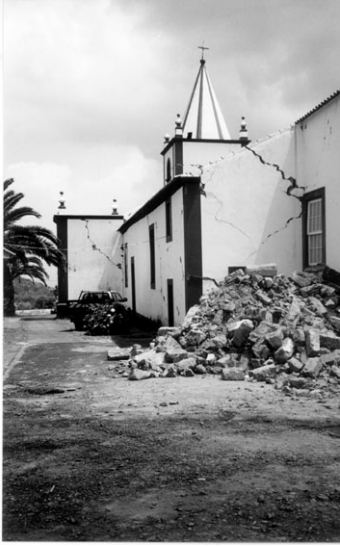
Figure 6 – Pedro Miguel church.

The Pedro Miguel church (no. 2) was one of the most damaged and was in a pre-collapse stage. As it can be seen in figure 6, there is evidence of extended shear failure of the walls (13). This church presented also large displacements on the interior columns and shear failure of the tower walls (14).

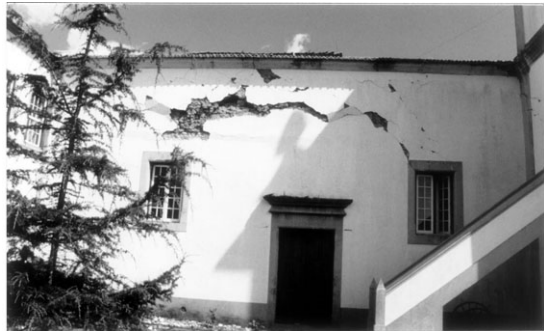
Figure 7 – Flamengos church.

In figure 7 one can see an example of hammering of the roof covering (7) that occurred in the Flamengos church (no. 1).

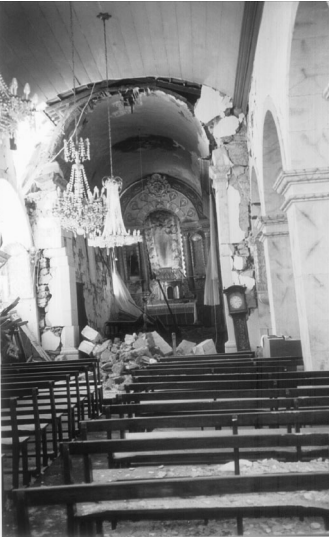
Figure 8 – Ribeirinha church.

Other problem that was registered in a large number of churches was the damage in the arches due to movements in the transverse direction in relation to the main body of the church. In figure 8 is presented one of the most

damage churches, the Ribeirinha church (no. 4), where this type of collapse mechanism (10) was present with total collapse of the arch between the nave and the apse.

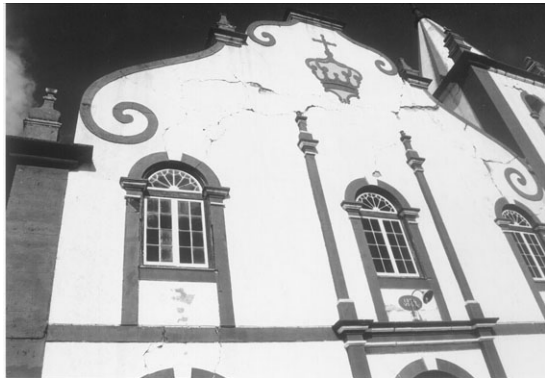
Figura 9 – Feteira church.

In figure 9 an example of failure of the fronton in the top of the facade (2) is presented. This was another of the most commons examples of damage registered in the observed churches, in this case the Feteira church (no. 13). This decorative element in most of the situations is not connected to the rest of the structure except on its base. That means that it acts like a cantilever for movements in the perpendicular direction of its plane. The vulnerability of this type of facade for movements in the pointed direction is evident.

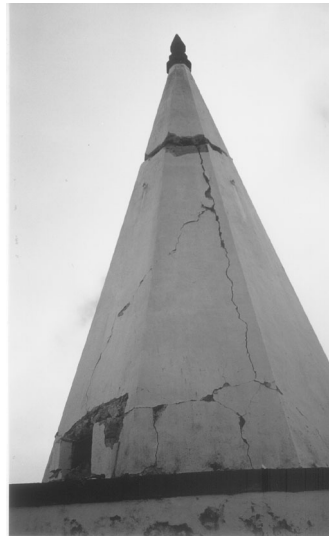
Figura 10 - Castelo Branco church.

In figure 10 one can see the damage occurred in the Castelo Branco church (no. 12) spire (16). This type of damage could be observed in some other churches although not so severe.
