AWR1843AOP Device Silicon Errata

Silicon Revision 1.0

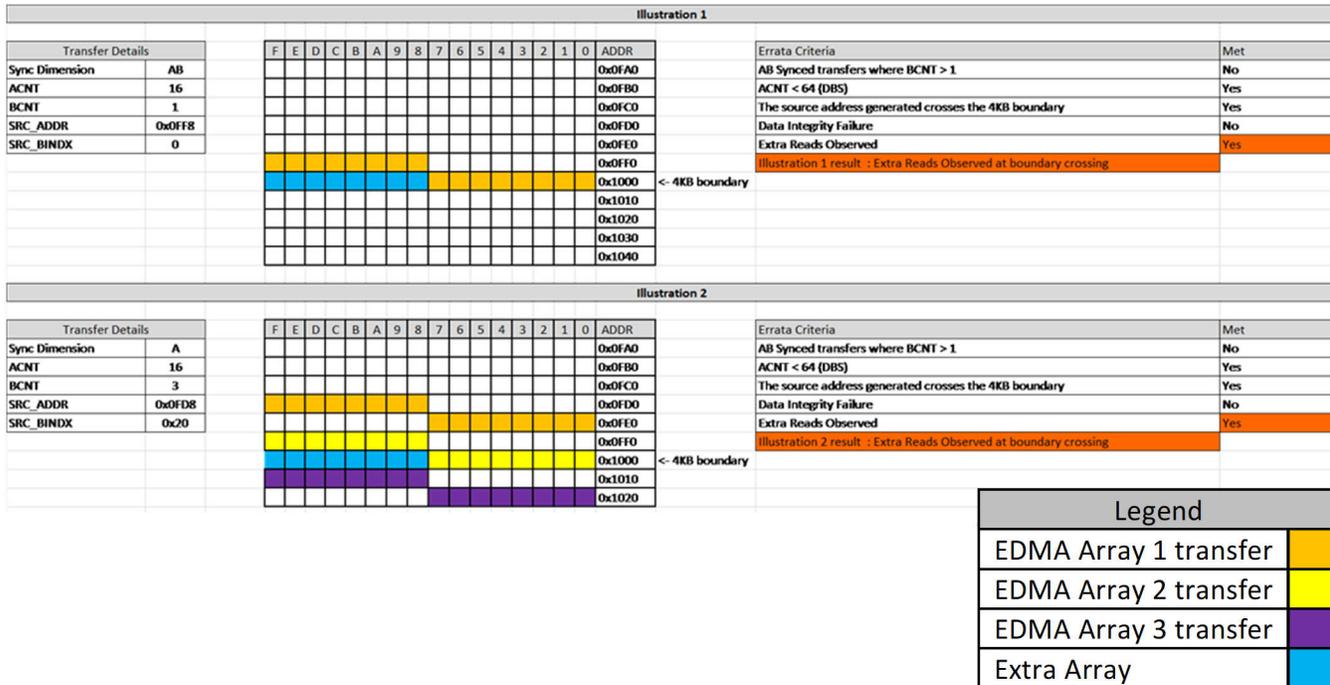
Figure 6-1. Scenario ID #3 – Extra Reads

For each extra read in **Scenario ID #3** for which **Condition [1]** is applicable, each index i above that satisfies the condition results in extra read from starting address SRC_ADDR + (i + 1) * SRCBIDX and of length equal to the distance from the start address to the boundary [that is, 0x1000 – X(i)]. Note: length < ACNT.

For **Scenario ID #3, Scenario ID #4, and Scenario ID #5**– EXTRA READS, another workaround besides avoiding the 4-KB boundary cross conditions, is to ensure that buffers involved in this kind of transfer are positioned so that extra reads stay within the physical memory boundaries. If the extra reads go to Reserved space or space blocked by the Memory Protection Unit (MPU), the TPTC generates a bus error interrupt to the processor.

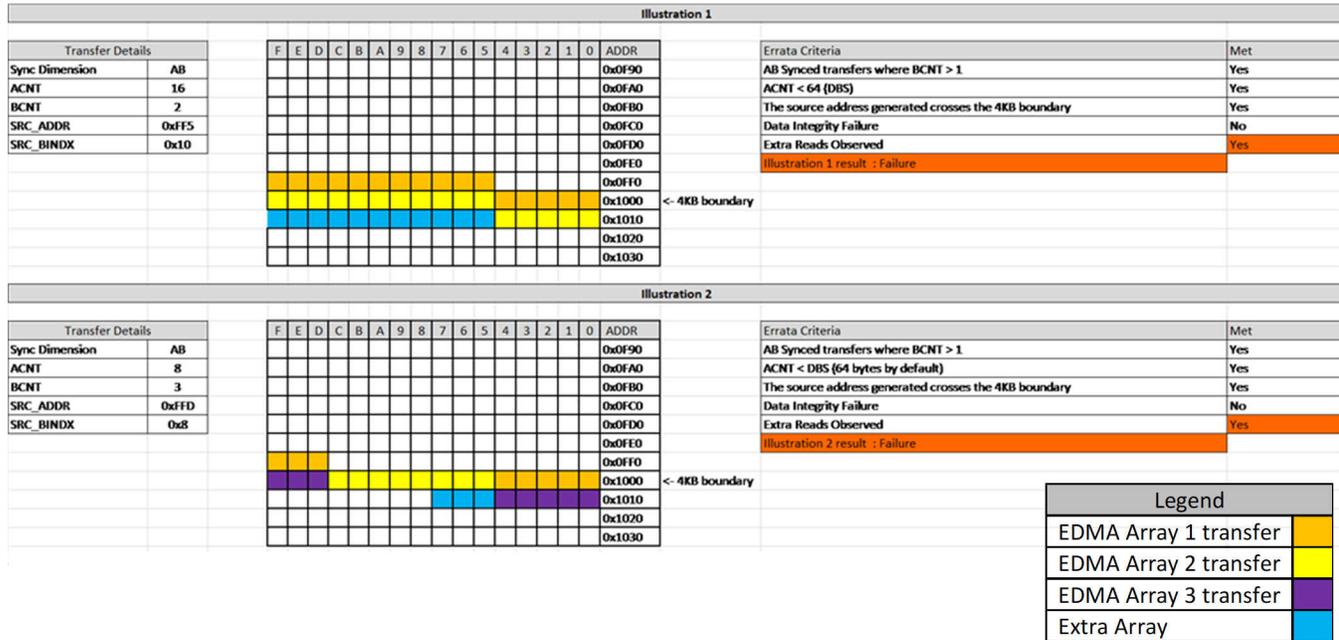
Figure 6-2. Scenario ID #4 – Extra Reads

For each extra read **Scenario ID #4** in for which **Condition [1]** is applicable, there is an extra read from starting address SRC + BCNT * ACNT (=SRCBIDX) of length equal to the distance of the start address to the boundary [that is, length is 0x1000 – X(i)], where i is the index of one and only 4-KB boundary crossing condition. Note: length < ACNT.

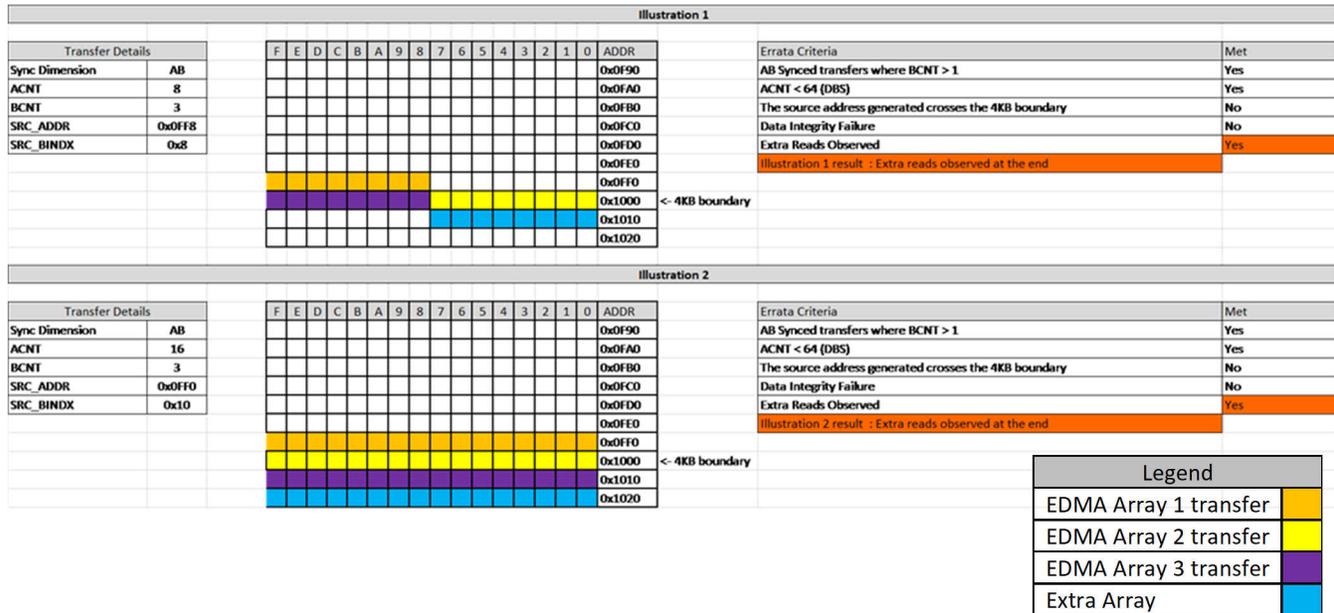
Figure 6-3. Scenario ID #5 – Extra Reads

For the extra read **Scenario ID #5** in for which **Condition [2]** is applicable, there is an extra read from starting address SRC + BCNT * ACNT (=SRCBIDX) of length equal to the distance of the start address and is of length ACNT.

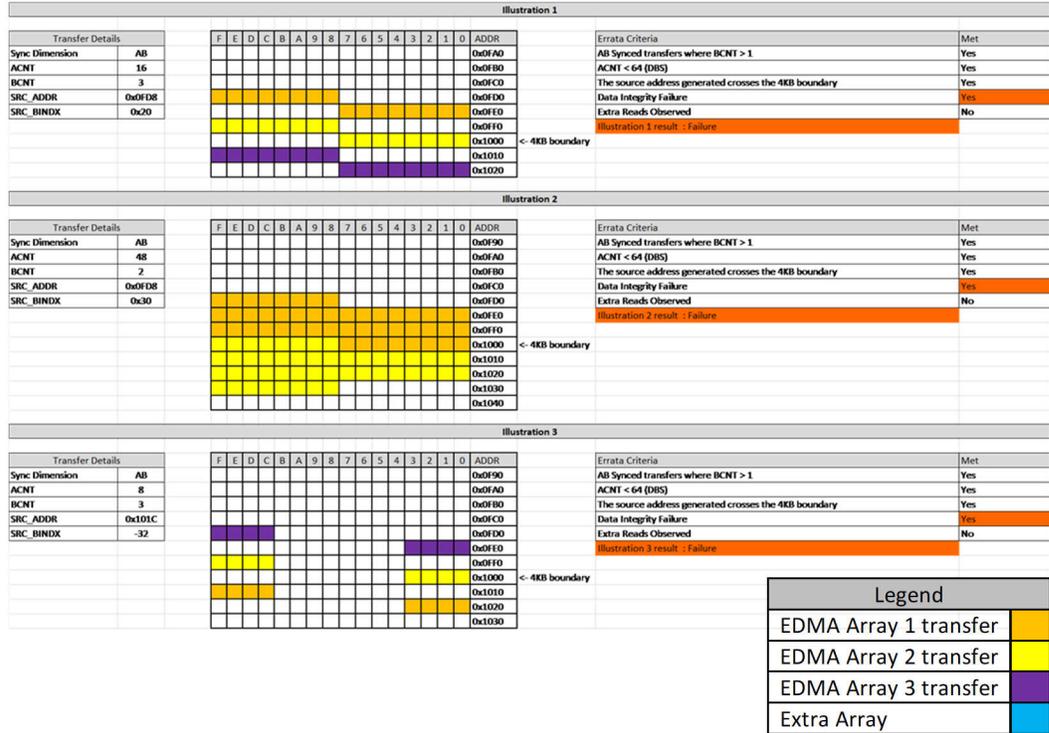
Figure 6-4. Scenario ID #1 – Data Integrity Failure

SCENARIO ID	CONDITIONS	DATA INTEGRITY FAILURES	HANGS	EXTRA READS
1	AB-sync BCNT > 1 ACNT not in [2,4,8,16,32] (ACNT < 64) OR ((ACNT = 64) AND (SRCBIDX != ACNT)) Source Addressing crossing 4-KB boundary for any of the BCNT number of ACNT transfers.	Yes (see Figure 6-4)	Possible	Possible
2	AB-sync with BCNT=1 or A-sync ACNT not in [2..24, 32] ACNT <= 64 Source Addressing crossing 4-KB boundary for any of the BCNT number of ACNT transfers.	No	Possible	Yes
3	AB-sync with BCNT=1 or A-sync ACNT in [2..24, 32] Source Addressing crossing 4-KB boundary for any of the BCNT number of ACNT transfers.	No	No	Yes (see Figure 6-1)
4	AB-sync BCNT > 1 ACNT in [2,4,8,16,32] SRCBIDX = ACNT ACNT * BCNT <=64 Source Addressing crossing 4-KB boundary for any of the BCNT number of ACNT transfers.	No	No	Yes (see Figure 6-2)
5	AB-sync BCNT > 1 ACNT in [2,4,8,16,32] SRCBIDX = ACNT ACNT * BCNT <=64 Source Addressing <i>does NOT</i> cross 4-KB boundary for any of the BCNT number of ACNT transfers; that is, NOT of Source Addressing crosses 4-KB boundary for merged source array of size ACNT * BCNT.	No	No	Yes (see Figure 6-3)

Prevent one or more of the conditions necessary for the problematic scenarios to happen.

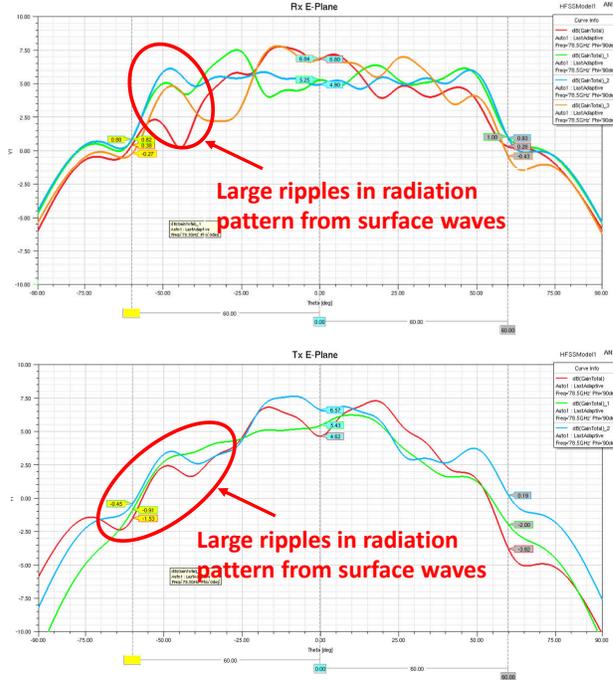
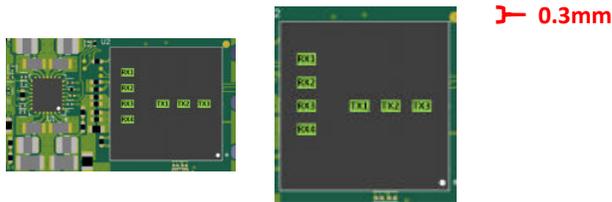
Figure 6-5. Small form factor board with PCB edge less than 0.3mm

Description: Large PCBs area around the E-plane causes surface waves that create large ripples in the elevation direction of the AoP antenna radiation pattern.

Keep the Edge of PCB close to the edge of the AoP device in the E-plane to minimize the surface wave ripples.
